CENTA GROUP
COMPLETE FIRE PROTECTION

HOSE REEL

Corrosion Proof (BB0210)

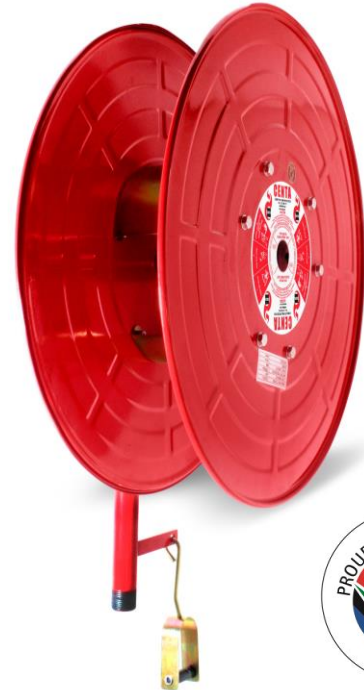
SPECIFICATIONS:

Hose Capacity (m):	30
Spindle:	Stainless Steel
Waterway:	Plastic
Hub Spacer:	M/Steel Electro Galvanised
Discs:	M/Steel Electro Galvanised
Frame:	M/Steel Electro Galvanised
Coating:	Heavy Epoxy
Nozzle:	Jet / Spray
Nozzle Material:	Nylon
Frame Mass (Kg):	5.98
Complete Mass (Kg):	16.94 (c/w 30m PVC Hose)
Compliance:	SANS 543
