**CENTA GROUP**  
COMPLETE FIRE PROTECTION

# HOSE REEL

**Stainless Steel (BB0416)**

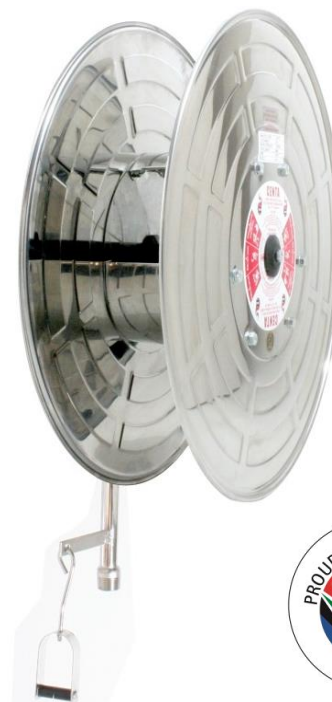
Hose Capacity (m):	30
Spindle:	Stainless Steel
Waterway:	Plastic
Hub Spacer:	Stainless Steel
Discs:	Stainless Steel
Frame:	Stainless Steel
Coating:	Polished
Nozzle:	Jet / Spray
Nozzle Material:	Nylon
Frame Mass (Kg):	5.39
Complete Mass (Kg):	16.34 (c/w 30m PVC Hose)
Compliance:	SANS 543
